Performance Evaluation of Firwin Hard Coat Insulation

Based on Independent Study conducted by
Catalytic Exhaust Products Limited
MDEC Presentation
October 2009

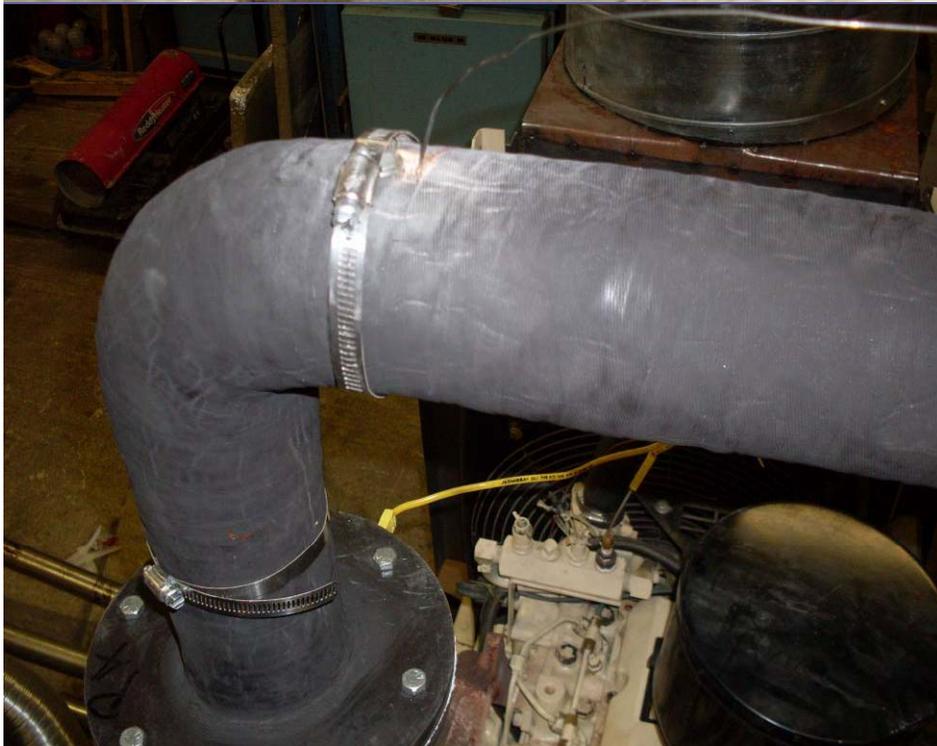
- Insulation type Firwin Hard Coat (HC):

- Outer layer
- Black color
- Composite fiber

- Inner layer
- High alumina ceramic fiber
- Temperature limit of 2300 °F (1260 °C).

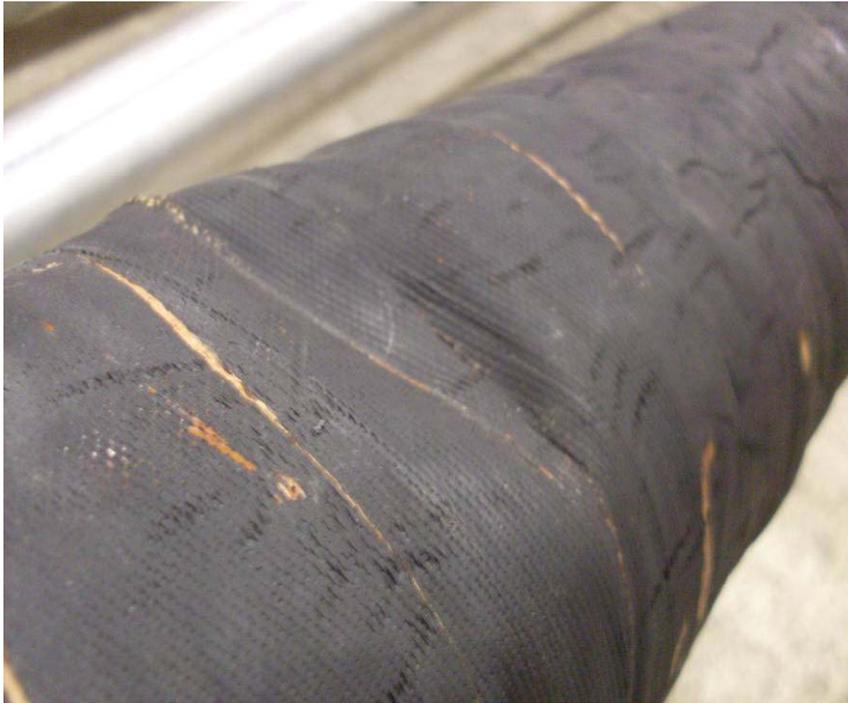
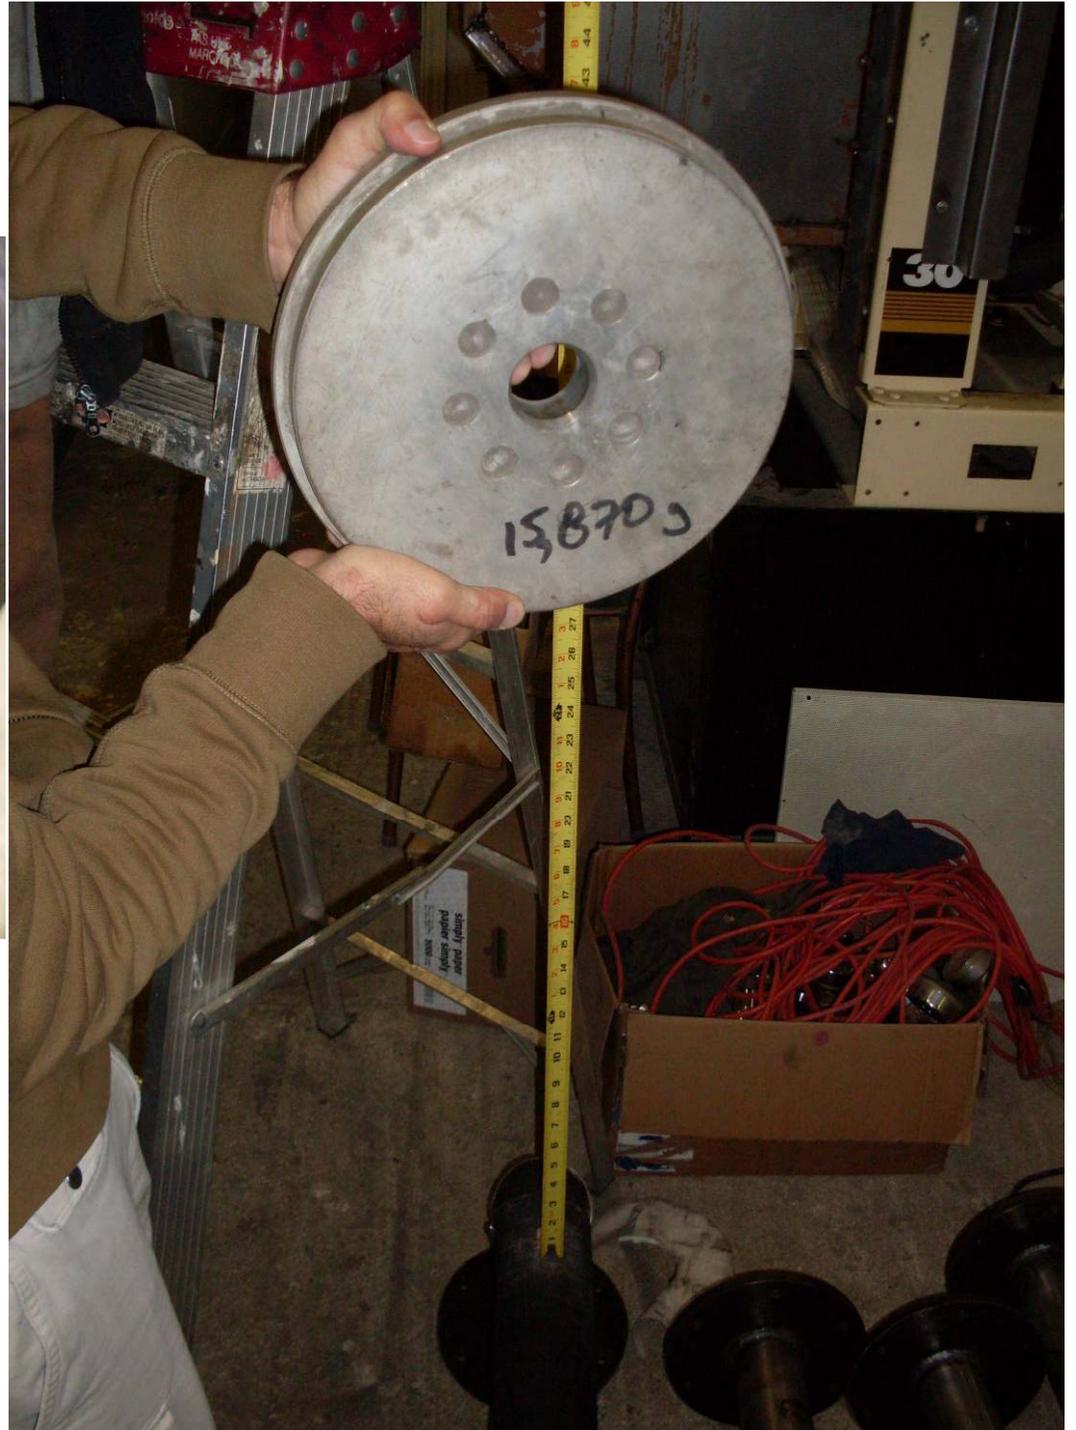
In this test 15.87 kg weight was dropped from a height of 4 feet on each insulation while strapped to the exhaust pipe.

Firwin HC was dented about 0.25" deep.

CEP HC with dent after the impact
